## Johnson Screens' Support Grids Solve Leakage Issues of Molecular Sieve

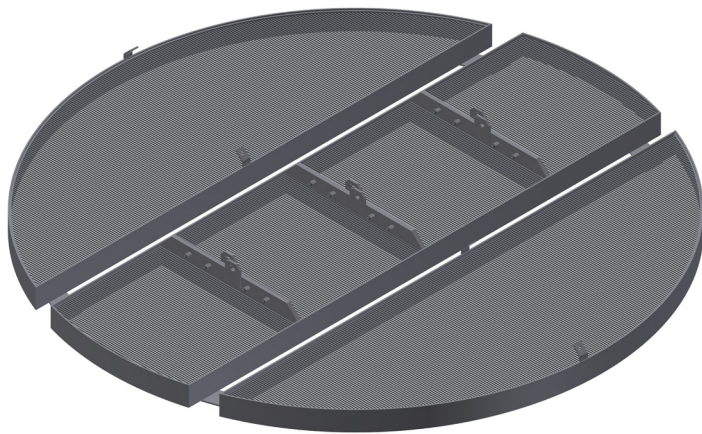
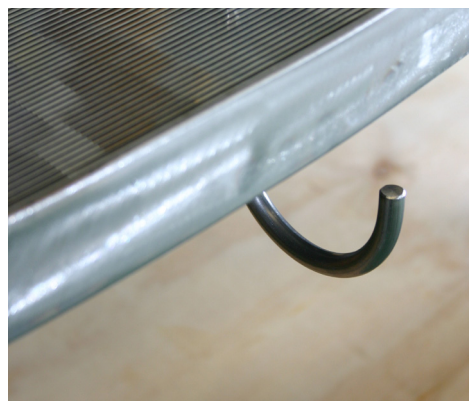
An updated design to the annulus seal ensures ease of installation, greater thermal growth allowance and improved sealing capabilities.

In large diameter molecular sieve dehydrators, additional technology advances have been developed to further secure the Johnson Screens support grid. The technology results in greater reliability of the unit through improvements in the sealing design.

The field service team first removed the leaking mesh grating assembly. Then the Vee-Wire support grid was installed using J-bolts to prevent uplift of the bed support during operation. Rope packing was installed between the vessel wall and the grid OD to prevent the possibility of bypass at the vessel/grid interface.
